Technical Note N-1096

CORROSION OF DSRV MATERIALS IN SEA WATER - 12 MONTHS  
NATURAL EXPOSURE AND 98 CYCLES IN PRESSURE VESSELS

May 1970

NAVAL CIVIL ENGINEERING LABORATORY  
Port Hueneme, California 93041

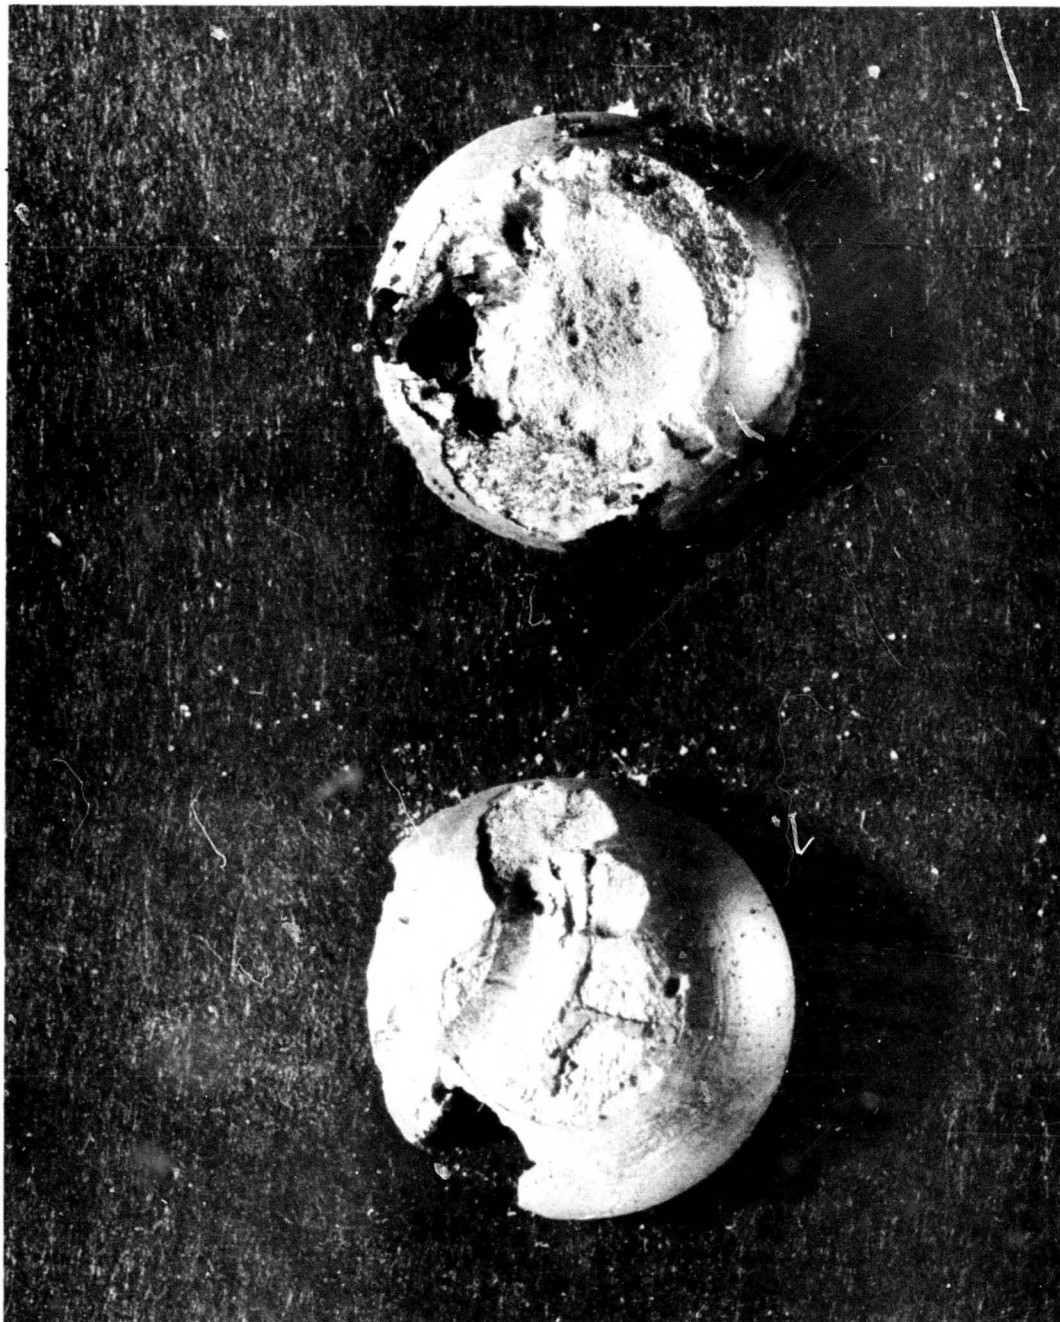
There was no failure of the paint or sealant at the strip-panel faying surface which resulted in any noticeable corrosion. However, sea water had penetrated up to 1/4 inch under the strip with DC-93046 sealant. Sealants PR-1527 and PR-1422 showed excellent adhesion at the faying surfaces while DC-93046 showed moderate adhesion and sealants DC-11 and sprayed PVC showed little or no adhesion. The PR-1422, DC-93046, DC-11 and sprayed PVC sealants had failed at the heads and backs of the 5052 aluminum alloy rivets used to fasten the strips to the panel. The rivets under the failed DC-93046 sealant were badly pitted as shown in Figure 2. There was no corrosion of the other fasteners on this panel.

Figure 2. Severely pitted 5052 aluminum alloy rivets exposed under failed DC-93046 sealant.

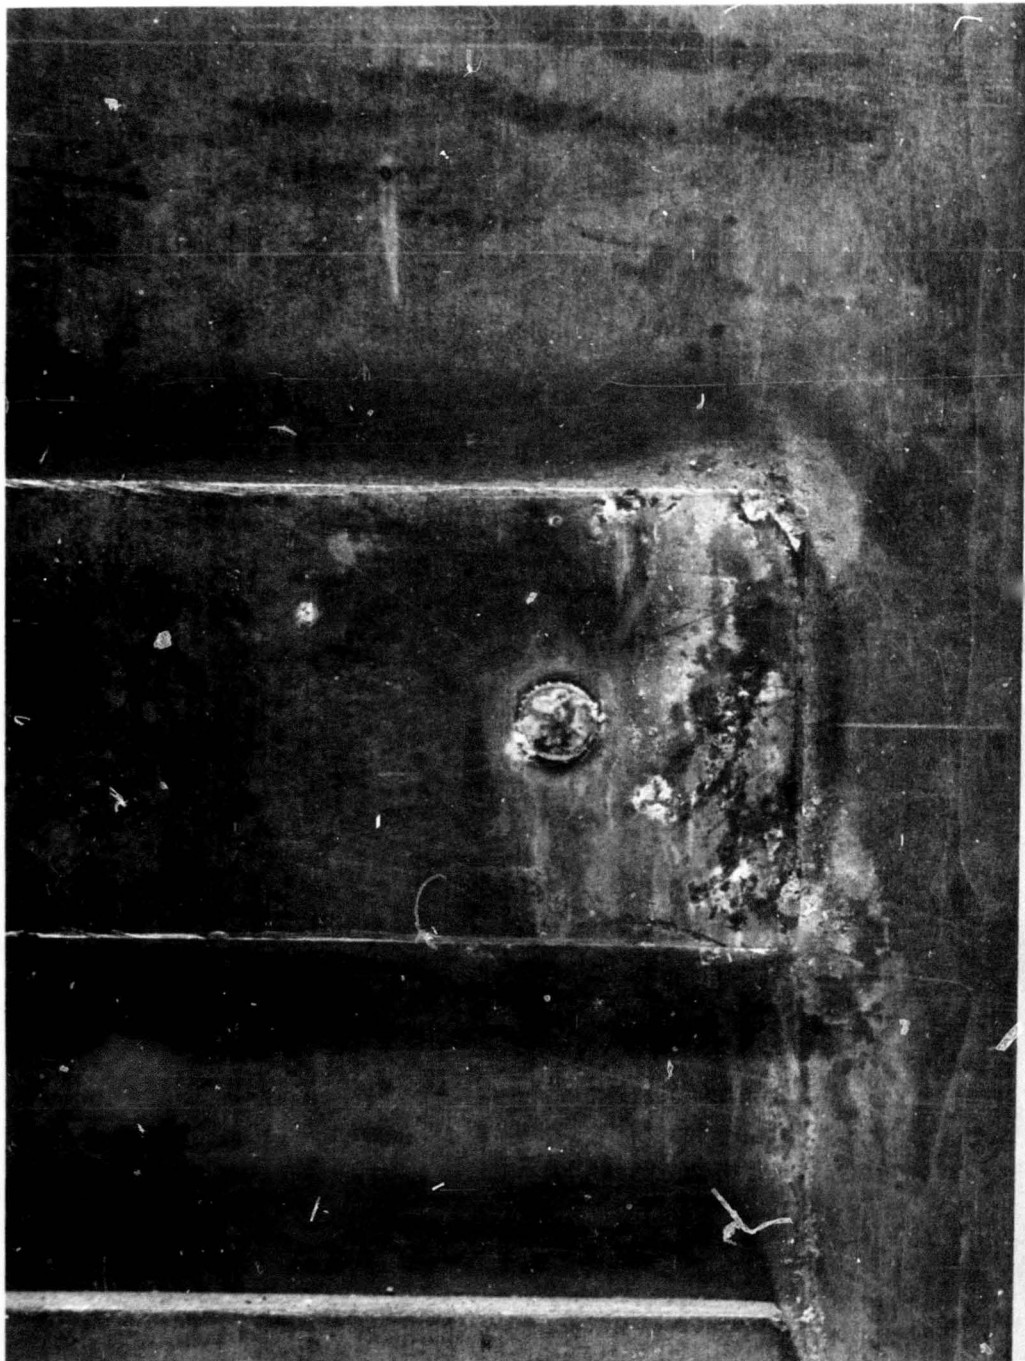
Specimen G8D. The specimen was covered with superficial rust stains. There was some pitting at the corners of the panel and on the attached strips as shown in Figure 3. This attack occurred during cycles 1 through 10 when the panel was in contact with the sides of the pressure vessel. The attack did not increase after the panel was insulated from further contact with the sides of the pressure vessel. The fasteners were uncorroded. There was a light film of corrosion at the faying surfaces indicating the inability of the zinc anode to completely prevent crevice corrosion. The zinc anode showed no visible consumption.

Figure 3. Arrested pitting on anodized 6061-T6 strip. Initiated by contact with steel vessel.
